NATIONAL REGISTER OF HISTORIC PLACES REGISTRATION FORM

_Thomas J. Lewis House____ name of property _Wabash County, Indiana__ county and State

Narrative Description

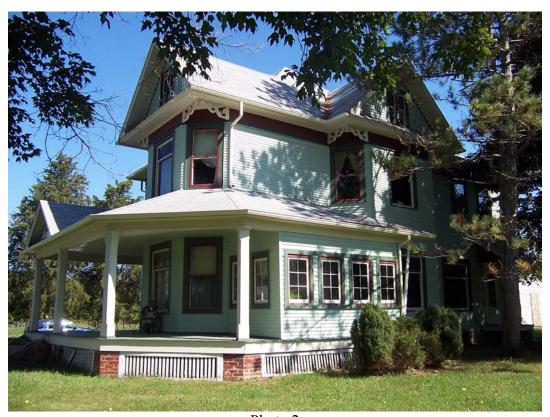
Photo 2

South Façade (Photos #2 & #3)

The south side is composed of three distinct sections. The first includes the porch and sunroom. The sunroom is accessible on the interior from the entry or an exterior door on the east end. There are four six-pane windows on the south façade of the sunroom.

The middle section on this façade is a 2-story 3-sided bay capped by a triangular gable similar to the configuration on the west façade. The only difference between the two bays is the use of a door instead of a window in the first floor west opening. As with the front façade, the bottom corners of the attic floor gable are accented with carved brackets. The triangular gable has two windows and scalloped siding with sawtooth trim along the bargeboard.

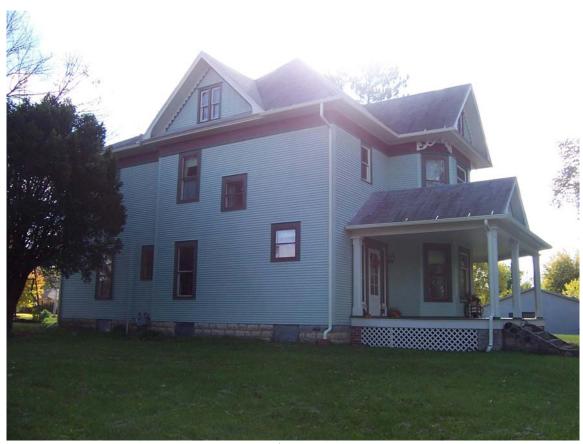
Photo 5

North Façade (Photo #5)

The plane of the north façade is relatively flat east to west. The window openings vary in size and are scattered asymmetrically over this façade. Three windows are found on the first floor, two on the second and one small opening in the staircase between the first and second floors. Eave treatment and cornice trim are identical to the previous facades of the house. The attic story roofline is broken by a triangular gable like those found on the south and west facades. Decorative treatment of this gable mirrors the previous two gables, but without the corner brackets.

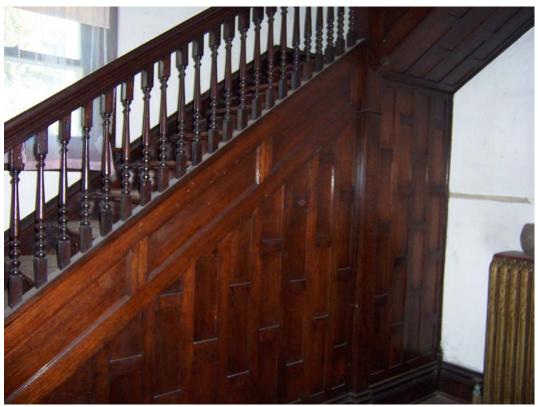
Photo 8

The front door opens into the entry containing the front staircase on the north wall leading up to the second story. The stained oak stair has turned balusters and square newel posts at the top, bottom and middle landing (Photo #8). The stairway has two small double hung windows on the north wall. On the east wall is a radiator. The south wall has two openings, one leading into the middle room and one leading into the front parlor. Paneling covers the wall under the staircase (Photo #8). There is one center ceiling fixture. The pine floor of the entry was originally covered with carpet.

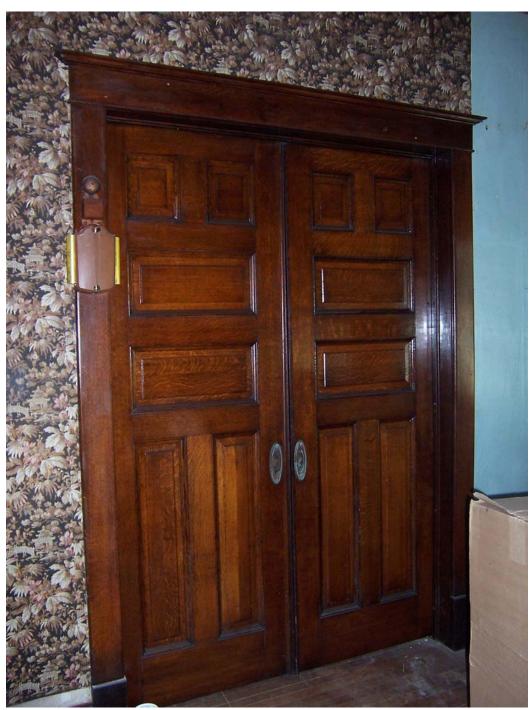
Photo 18

From the middle room to the east are double pocket doors leading into the dining room (Photo #18). The south wall of the dining room has a large window with the top third stained glass (Photo #12). East of this window is an exterior door leading to a small porch. On the east wall is a door which leads to an enclosed back stairway (Photo #16). This stairway is oak and much simpler than the entry stair.
